**CULTURAL LANDSCAPE REPORT  
NORTH BRIDGE UNIT  
MINUTE MAN NATIONAL HISTORICAL PARK**

**SITE HISTORY, EXISTING CONDITIONS,  
ANALYSIS & EVALUATION, TREATMENT RECOMMENDATIONS**

**CONCORD  
MASSACHUSETTS**

January 2004

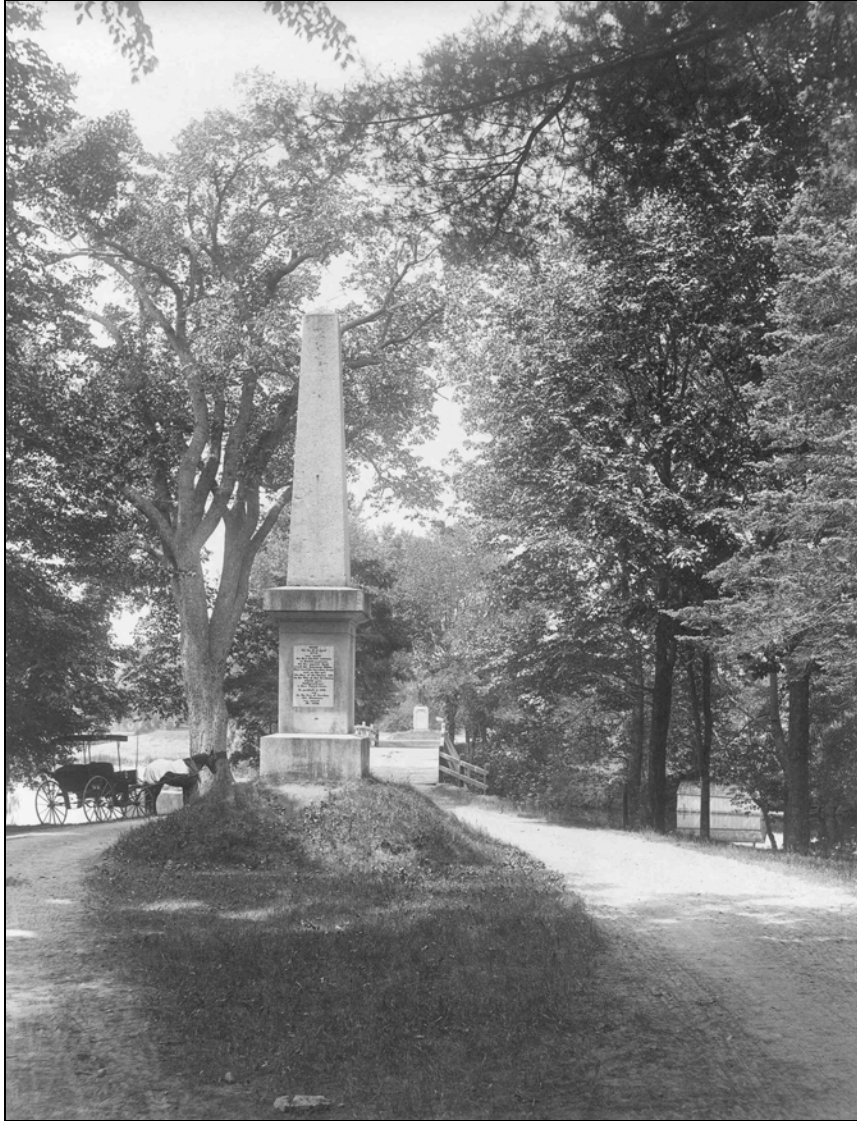
**Figure 97. View west of trees adjacent to the 1888 commemorative North Bridge, c. 1888 to 1908. The “great elm” is depicted left of the 1836 Battle Monument. Note also in the photograph The Minute Man statue (background) and the Buttrick boathouse (right). (MIMA Photographic Collection, Box 12, #34205, MIMA Archives)**

Historic Condition: Two large elms that stood along the eastern bank of the Concord River, framing an eastern view of the 1836 Battle Monument, appear on a c. 1852 engraving and on an 1859 stereoscopic view of the monument (see Figures 15-16). One of the elms, referred to in an 1835 deed as the "great elm," may also be depicted on the 1775 Doolittle engraving "The Engagement at the North Bridge in Concord (see Figure 9)."<sup>236</sup> This tree stood at the southern corner of the eastern bridge abutment. The second elm, which stood at the northern corner of the eastern bridge abutment, appears in poor condition on both the 1850s engraving and stereoscopic view. Historic photographs indicate the second elm survived into the 1880s, but had died by 1888. The "great elm" survived until at least 1913, but was gone by 1921. Photographs depict the allée ending at the edge of the river, running along the outside (north and south) of the two large elms. Trees growing adjacent to the western abutment of the bridge and partially encircling the quarter-acre landform under The Minute Man statue are evident in historic photographs dating from the late 1800s and early 1900s. The 1930, 1943, and 1954 aerial photographs also indicate trees typically grew in these locations, with varying density (Figures 97-98).

Mature trees bordering the perimeter of the quarter-acre landform (T-01) and trees growing adjacent to the 1956 commemorative North Bridge abutments are historic features of the commemorative landscape.

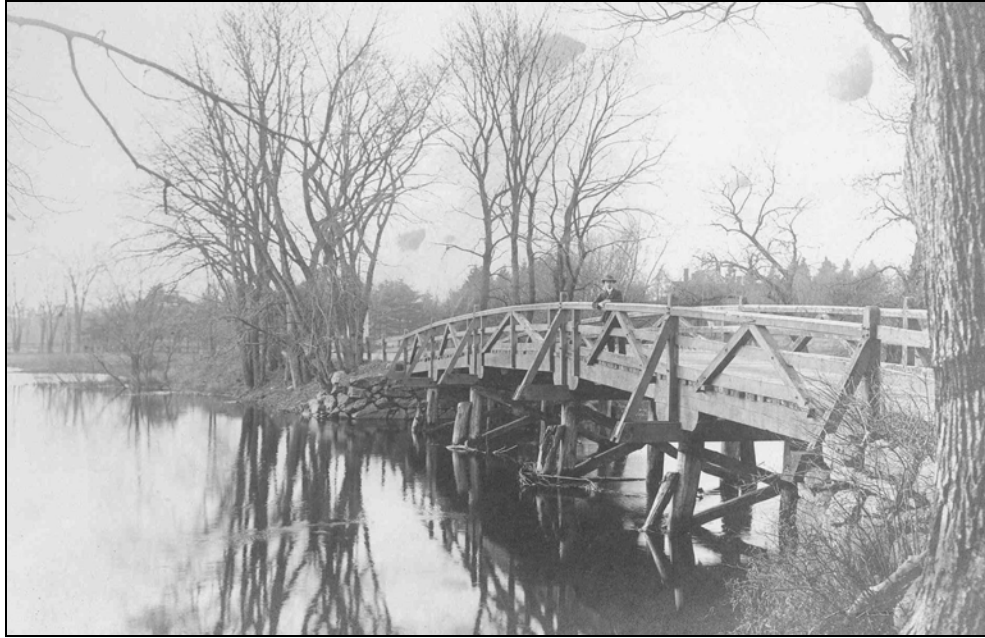
**Figure 98.** View west of trees adjacent to the western abutment of the 1888 North Bridge, c. 1888 to 1908. (MIMA Photographic Collection, Box 12, #34170, MIMA Archives)

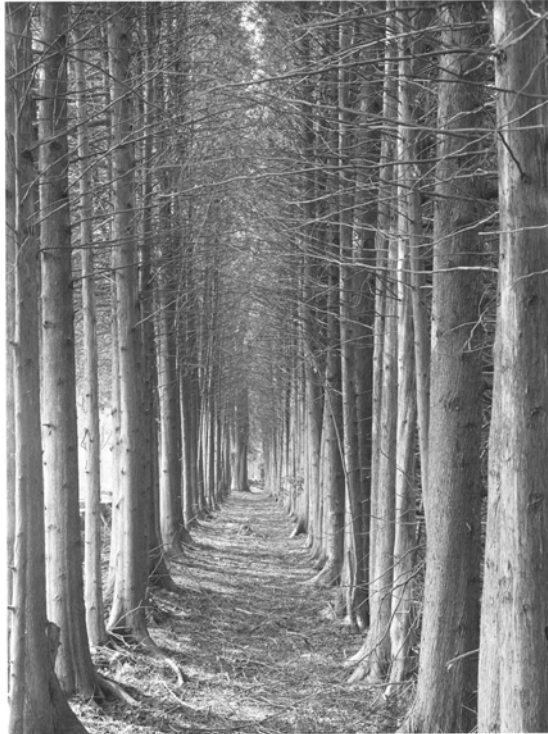
**Figure 99.** View south through double row of arborvitae, May 18, 1902. (Robbins Collection of H. Wendell Gleason Photographic Negatives, II.1902.15, Concord Free Public Library)

Historic Condition: According to the park's General Management Plan, "a double row of arborvitae were planted by the town of Concord on April 19, 1825, the 50<sup>th</sup> anniversary of the fight."<sup>241</sup> The double-row of arborvitae is depicted on an undated postcard and in several early 1900s photographs (Figure 99). A 1962 land appraisal for the Simmons houselot describes the vegetation as "a double row of fifty arborvitae, estimated over twenty feet tall."<sup>242</sup>

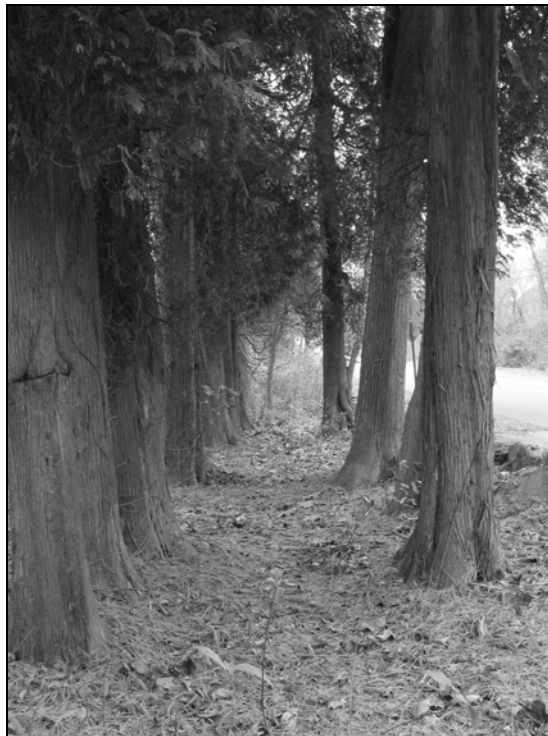
Existing Condition: The double row of arborvitae borders the Simmons houselot along the west side of Monument Street. Thirty-four trees remain, some are in poor condition. Stumps mark the location of missing trees. The rows are about six feet apart and trees within the rows are as close together as two feet. Trunk diameters vary from 10 to 24 inches (Figure 100).

**Figure 100.** View north through double row of arborvitae, 2002. Photograph depicts the northern section of the planting, where the double row is still clearly visible. (OCLP)

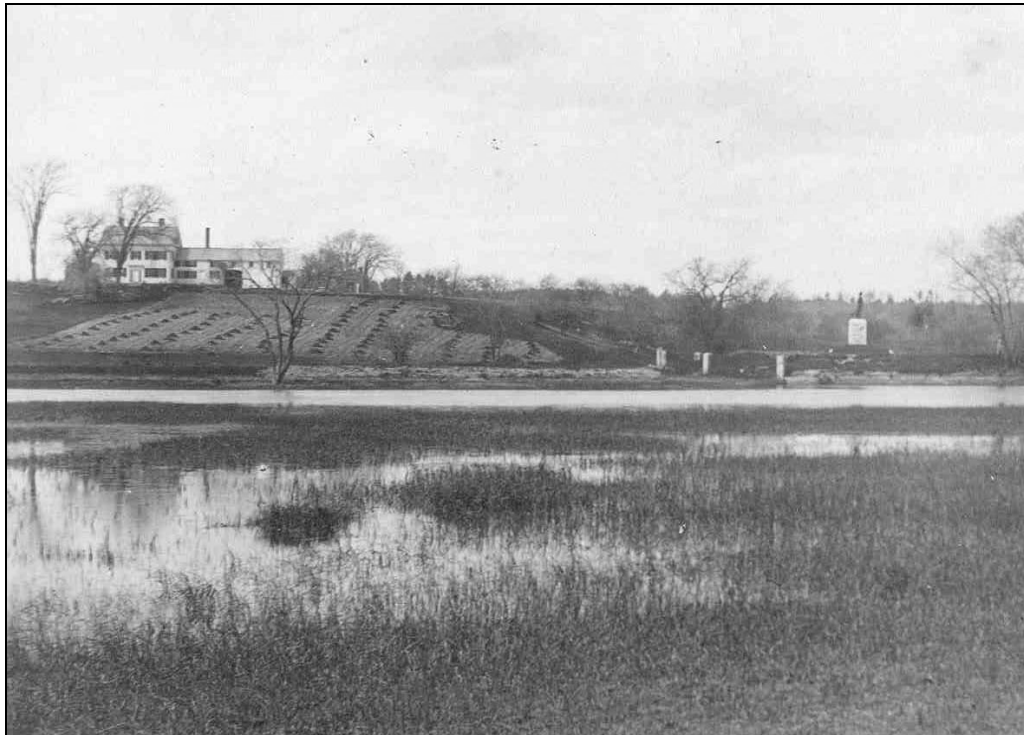
**Figure 101.** View north of the Buttrick farm and Stedman Buttrick house. Note the Concord River, the northern edge of Sargent's field (foreground), and The Minute Man statue and fencing (right). Photograph by Alfred Hosmer, c. 1880-1888. (MIMA Photographic Collection, Box 12, #34307, MIMA Archives)

**Historic Condition:** In 1775, the site included (from north to south) a pasture, a tilled field, and a wet meadow. The homes of Ephraim and Willard Buttrick stood on the east side of Groton Road (east branch), between the pasture and the tilled field. Just prior to the battle at the North Bridge, a British company took position around the houselots to guard the approach to the bridge. Engravings from the mid-1800s (see Figure 17) depict an open landscape south of the house sites, and photographs from the late 1800s indicate the area between the houses and the river included both a tillage field and a hayfield (wet meadow). By the 1880s, a house built by Stedman Buttrick I stood over the foundation of the Ephraim and/or Willard Buttrick house(s) (Archeological Site A-04) and a sprawling orchard grew around the house and down the eastern slope of Buttrick Hill. Also noted in historic photographs is a border of evergreens along the western boundary of the farm (Figures 101-102).

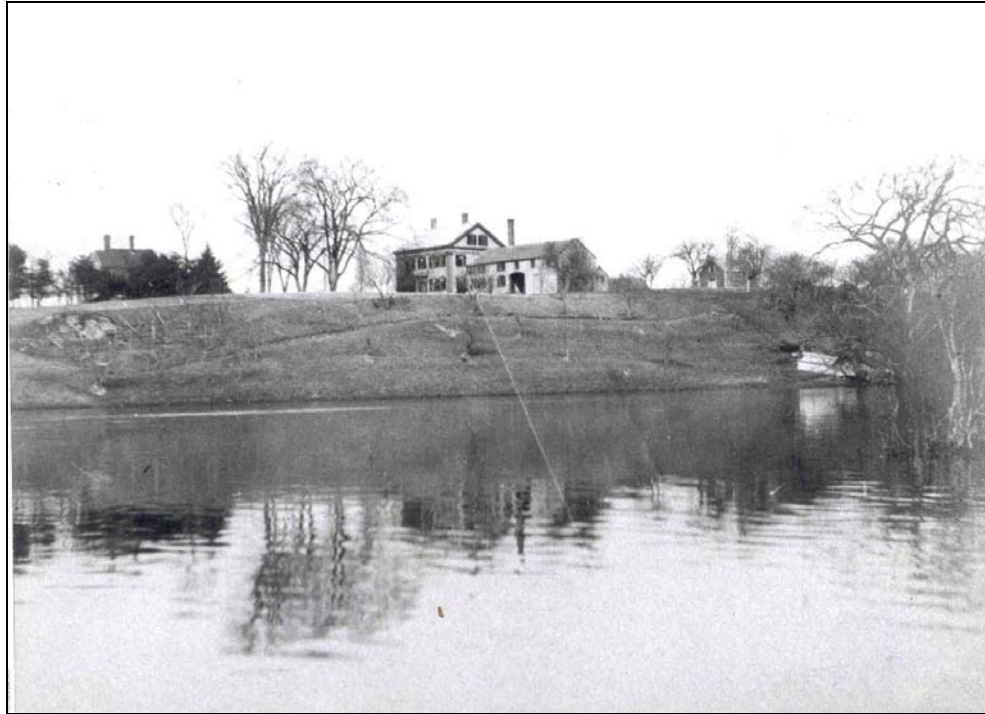
**Figure 102. View northwest of the Buttrick farm and Stedman Buttrick house. Note the orchard growing along the hillside, the row of mature pine trees growing along the border of the Battle Lawn estate (left), and the Battle Lawn gardener's cottage in back of the evergreens. Photograph by Ralph Holden, 1890. (Photograph depicted in Ruth Wheeler's "North Bridge Neighbors")**

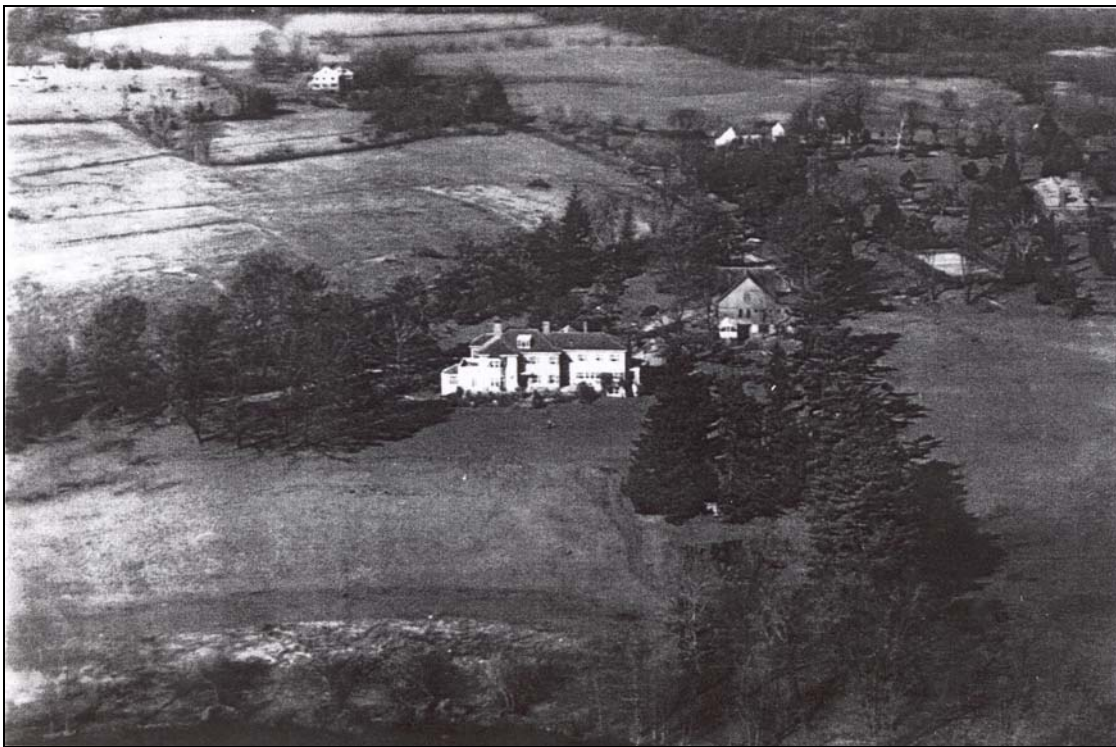
**Figure 103.** Aerial view north of Overlea, c. 1925-1952. Note mature planting associated with the Battle Lawn (Overlea) estate, the renovated Battle Lawn mansion, and the stable. Also note features associated with the Buttrick estate including the mature row of evergreens separating the two estates and the Buttrick mansion and pool (left). (Photocopy of a photocopy located in Photograph Files, Concord Free Public Library)

mansion. Plantings associated with the formally designed landscape, known as the Battle Lawn estate, included specimen trees (deciduous and evergreen), ornamental trees and shrubs, and a flower garden in the center of the circle drive at the front of the mansion. A manicured lawn and vines growing on the mansion are also noted in historic photographs (see Figures 48, 51-52). The land sloping to the river, south of the mansion, appears as a hayfield in a late 1800s photograph. In 1926 Stedman Buttrick III (neighbor to the east) purchased the Battle Lawn estate. Aerial photographs indicate Buttrick extended a garden path between the c. 1920s Buttrick estate gardens and the Battle Lawn (then known as Overlea) mansion between 1943 and 1954. Mature trees along the southern (Concord River) and eastern perimeter of the field are noted on the 1943 aerial photograph. The WPA map indicates the property was a market garden in 1939, bordered by wetlands along the river. The 1954 aerial photograph depicts two rectangular crop gardens on the parcel (Figure 103).

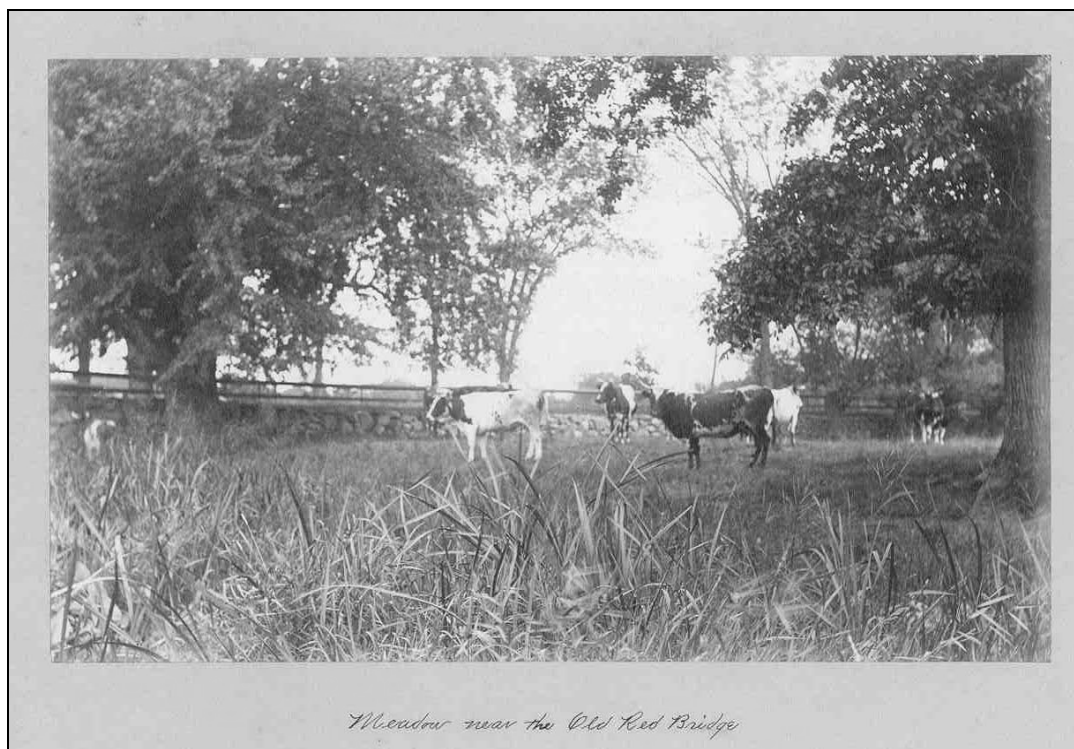
Figure 104. View northwest of cows grazing in Keyes Pasture, c. 1900. Also depicted in the photograph is stone wall (W-33). (MIMA Photographic Collection, Box 15, MIMA 24441, MIMA Archives).

Historic Condition: A stone wall in the approximate location of stone wall (W-33) in 1775. A stone wall with a board rider appears in the same location as stone wall (W-33) in a c. 1900 photograph of Keyes pasture (see Figure 104).<sup>288</sup> A wall in the same location is also depicted on the 1908 layout plan for Lowell Road.

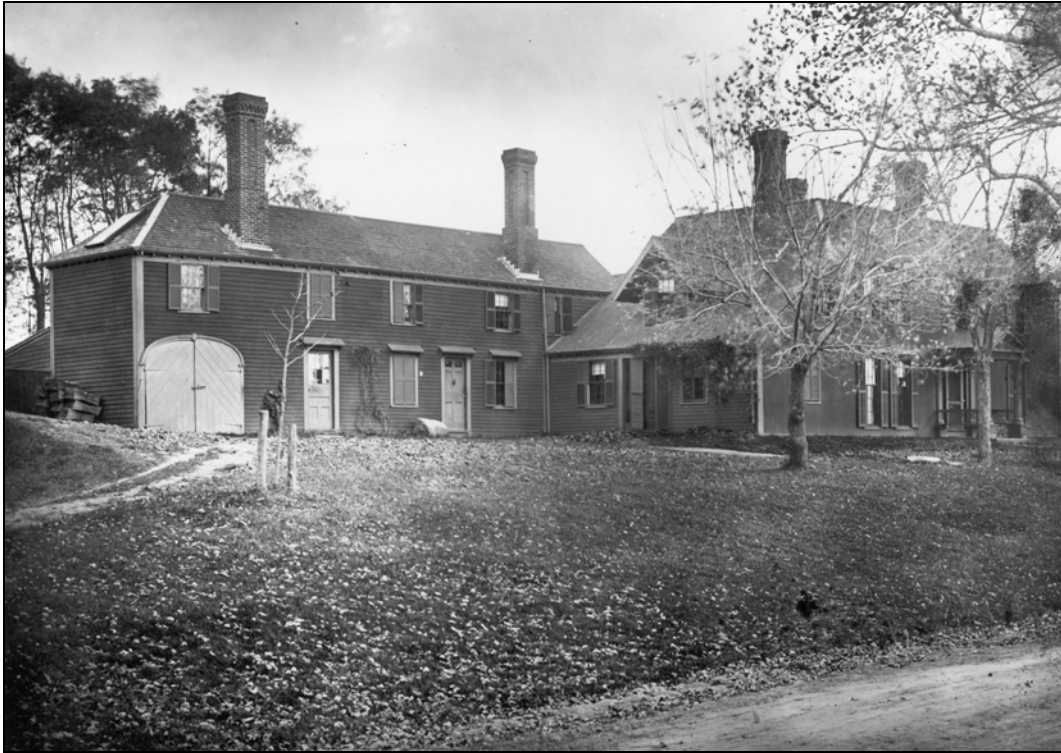
Figure 106. View southeast of the Elisha Jones house, c. late 1800s-early 1900s. Monument Street is in the foreground. (Halliday Photographic Collection, Cary Memorial Library)

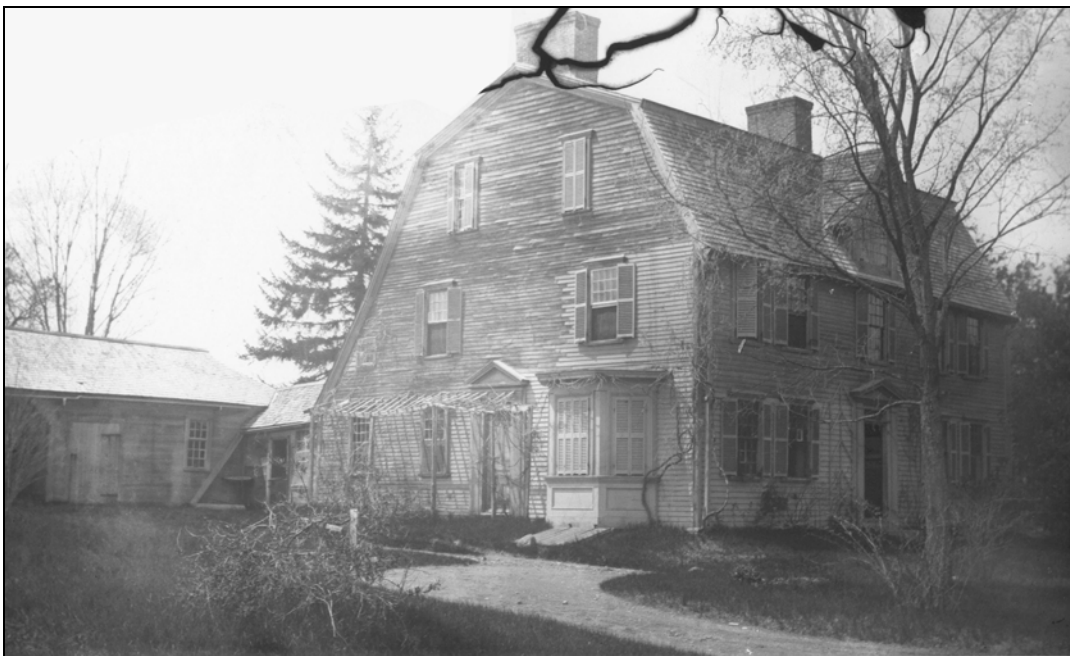
**Figure 107. View northwest of the Old Manse. Photograph by Alfred Hosmer, c. 1880-1902. (Hosmer Photographic Collection, III.125, Concord Free Public Library)**

Historic Condition: The house was constructed c. 1769 (Figure 107).

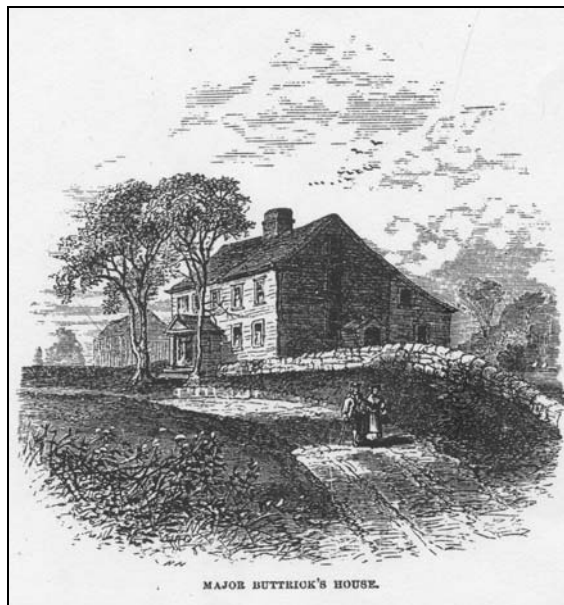
Figure 108. Engraving of the Major John Buttrick house as depicted in "The Concord Fight," *Harper's New Monthly Magazine*, May 1875. Illustrated on the engraving is a stone wall located in the approximate location as stone wall (W-24).

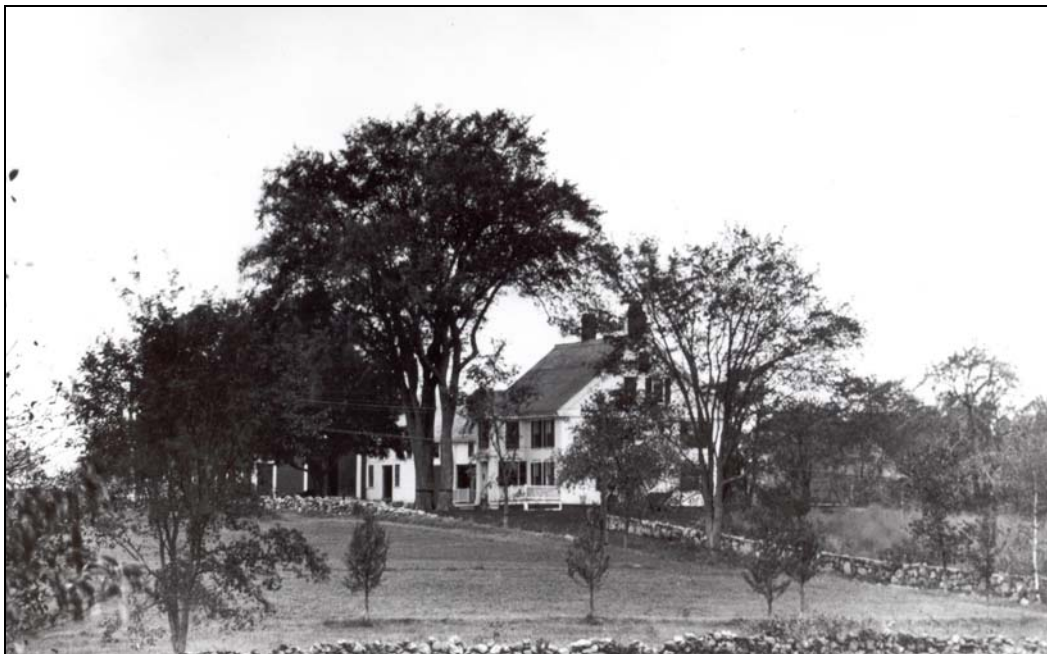
Figure 109. View northwest of the Major John Buttrick house. Two large outbuildings or barns appear left (west) of the house. Photograph by Henry A. Castle, c. 1900-1906. (Castle Photographic Collection, Plate 210, Concord Free Public Library)

Historic Condition: Stone wall (W-25) did not exist in 1775. A stone wall in the same location as stone wall (W-25) is depicted on a c. 1900-1906 photograph of the Major John Buttrick house (see Figure 109).

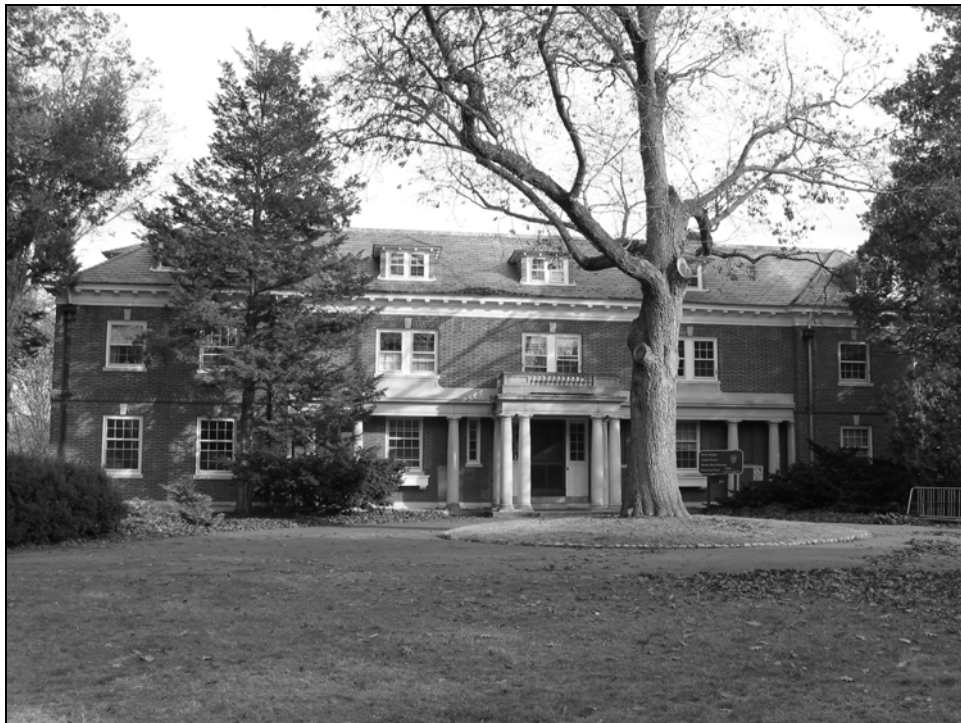
Existing Condition: The mansion is located on the east side of Liberty Street, setback from the road approximately 225 feet. The two-and-one-half story, Classical Revival-style brick building has a rectangular-plan main block flanked by two-and-one-half-story hip roof wings. The building contains the North Bridge Visitor Center and NPS office space (Figure 110).<sup>269</sup>

Figure 110. View east of the Buttrick mansion (North Bridge Visitor Center), 2002. (OCLP)

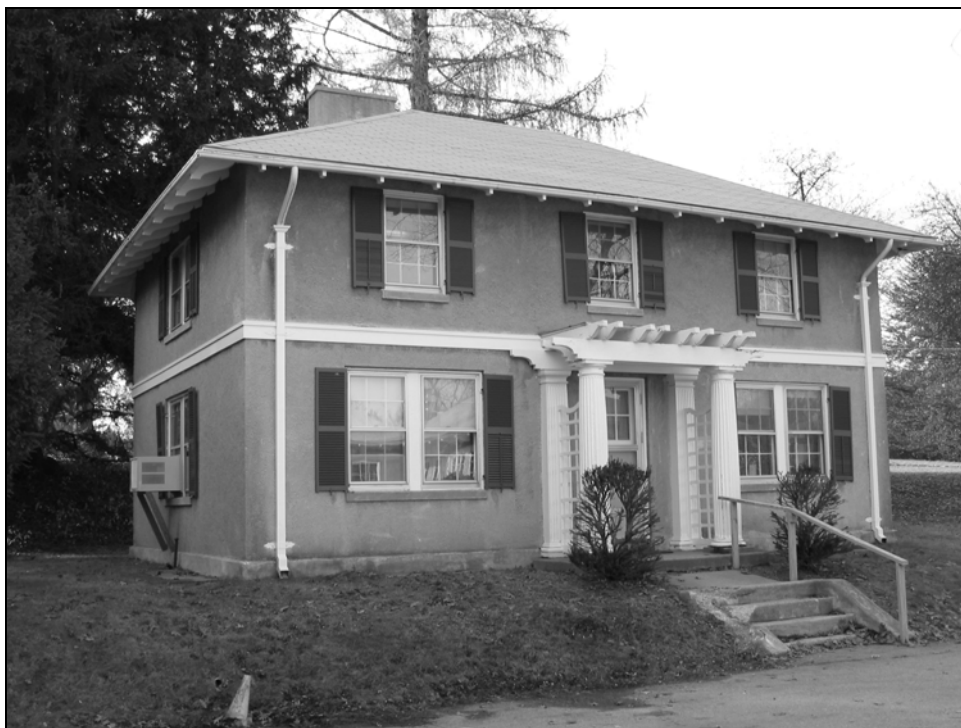
Existing Condition: The caretaker's cottage is located north of the Buttrick mansion, on the east side of Liberty Street. The cottage has a rectangular footprint. Its exterior walls are parged stone (Figure 111).

Figure 111. View northwest of the caretaker's cottage, 2002. (OCLP)

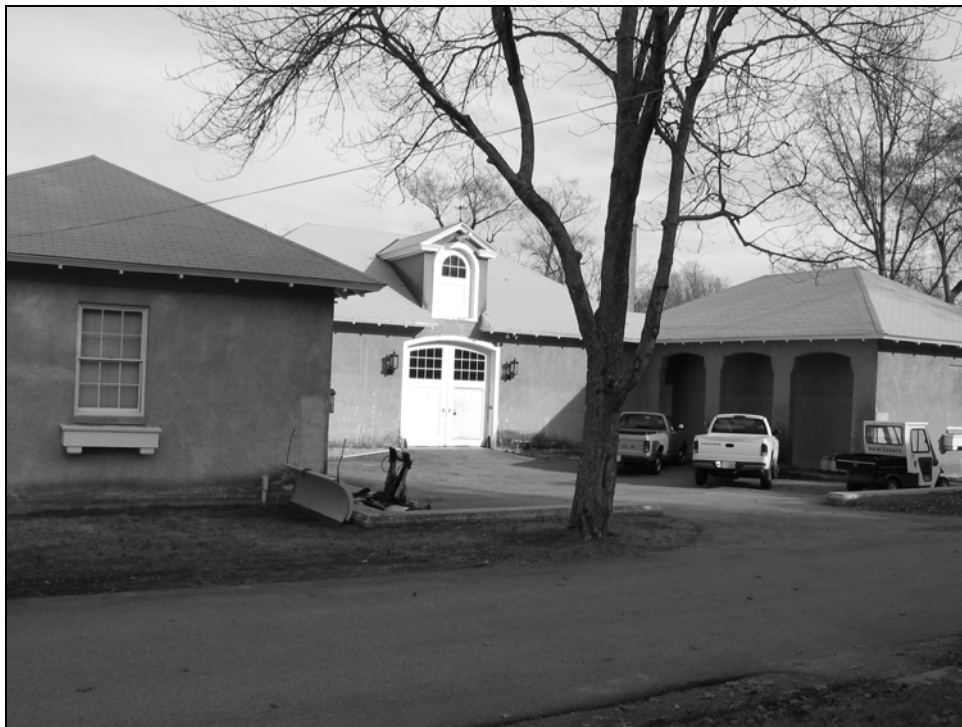
Existing Condition: The carriage house is located across from the caretaker's house. The building has a U-shaped footprint, and its exterior walls are parged stone (Figure 112). The building is used as a park collection storage facility and maintenance facility.

Figure 112. View southwest of the carriage house, 2002. (OCLP)

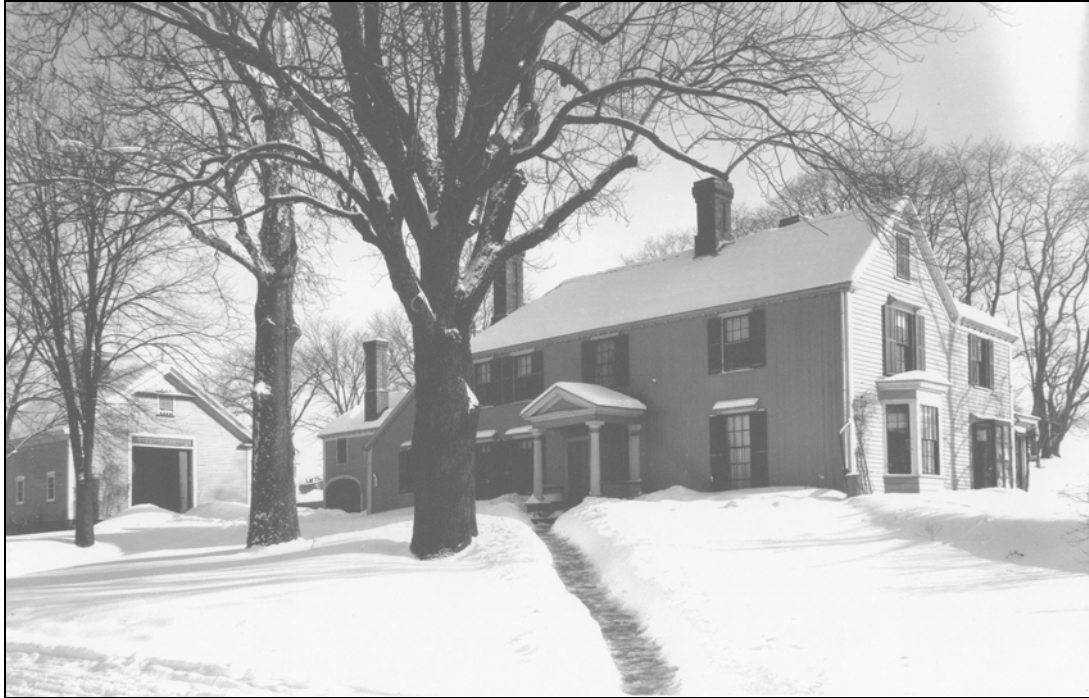
Figure 113. View northeast of the Elisha Jones house and barn (left), June 30, 1904. (Robbins Collection of H. Wendell Gleason Photographic Negatives, 1904.5, Concord Free Public Library)

Historic Condition: The barn originally stood in Sargent field, on the opposite side of Monument Street. It may have been built in the eighteenth century. In 1864, John Shepard Keyes, the owner of both Sargent field and the Elisha Jones house at the time, moved the barn across the road and reassembled it just north of the Elisha Jones house. According to Keyes, “the barn was shortened one bent of 12 ft. and refitted with a cellar &c where it now stands.”<sup>270</sup> The barn appears in historic photographs and on historic maps dating from the 1880s to the mid-1920s (Figure 113). It appears to have been removed by 1941.<sup>271</sup>

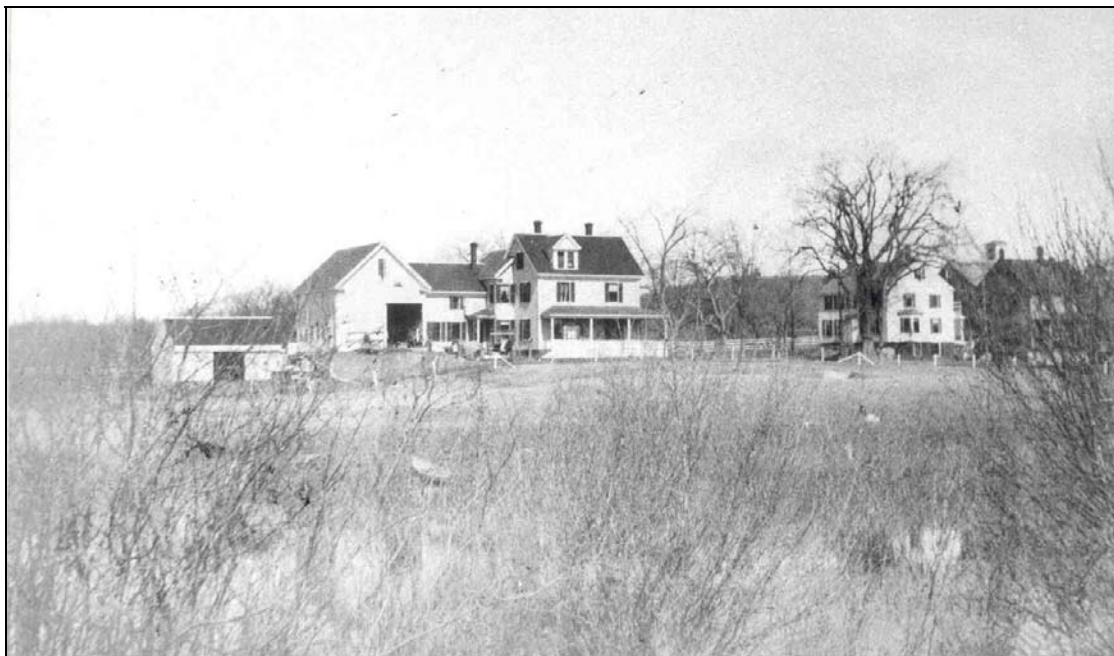
Figure 114. View northeast of the Lewis Flint house and outbuildings (left). Photograph by Ralph Holden, 1890. Lewis Flint reportedly constructed his house on the seventeenth-century John Flint house site. Buildings to the right (east side of Monument Street) belonged to other Flint family members and were not within the present-day North Bridge Unit. (Photograph depicted in Ruth Wheeler's "North Bridge Neighbors")

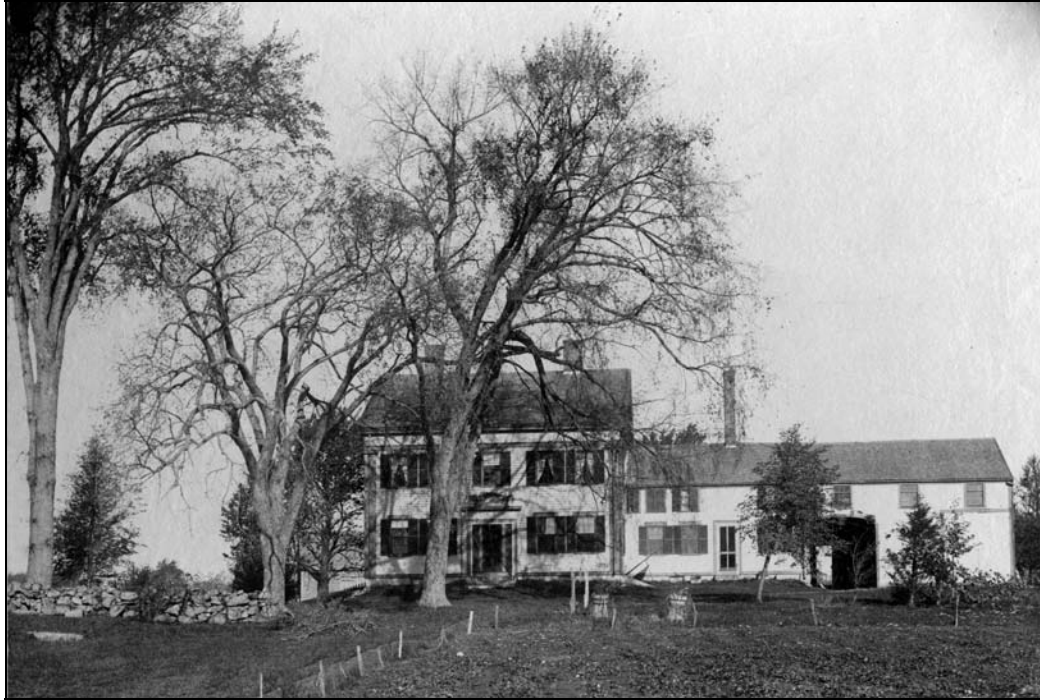
Figure 115. View north of the Stedman Buttrick house, constructed on the site of the Ephraim and/or Willard Buttrick house sites in the mid-1800s. Photograph by William Brewster, c. 1895. Note the stonewall (left) and the large elm trees. These features survived into the 1900s and are depicted on the "Plot Plan for Stedman Buttrick, Esq., Concord Mass" (1911), and the "Topographic Plan, Buttrick Property" (1928) Figures 55 and 67 within this report. (SPNEA Archives)

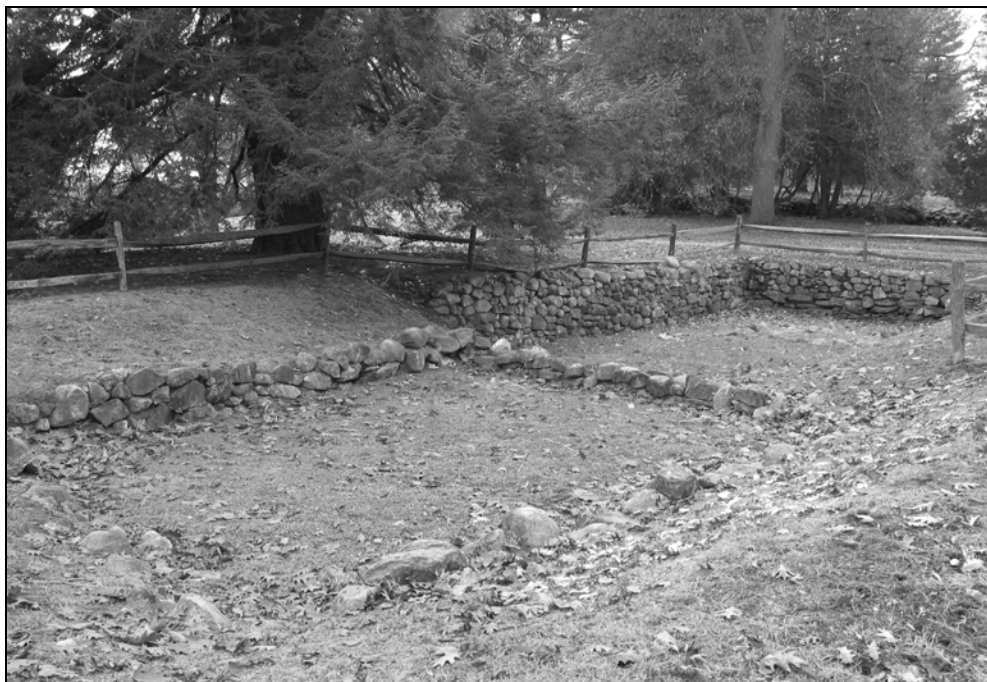
Figure 116. View southwest of the Ephraim and/or Willard Buttrick house site, 2002. (OCLP)

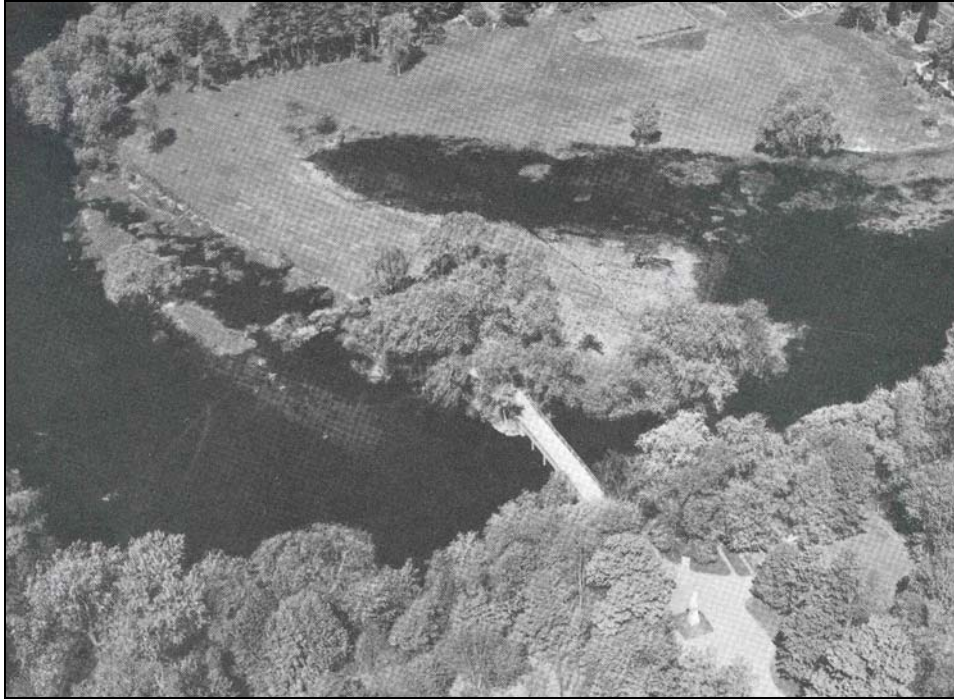
Figure 117. Aerial view northwest of the Groton Road causeway (west of the 1956 commemorative North Bridge), 1950. Also shown is the 1836 Battle Monument (lower right). (Photograph depicted in Ruth Wheeler's "North Bridge Neighbors")

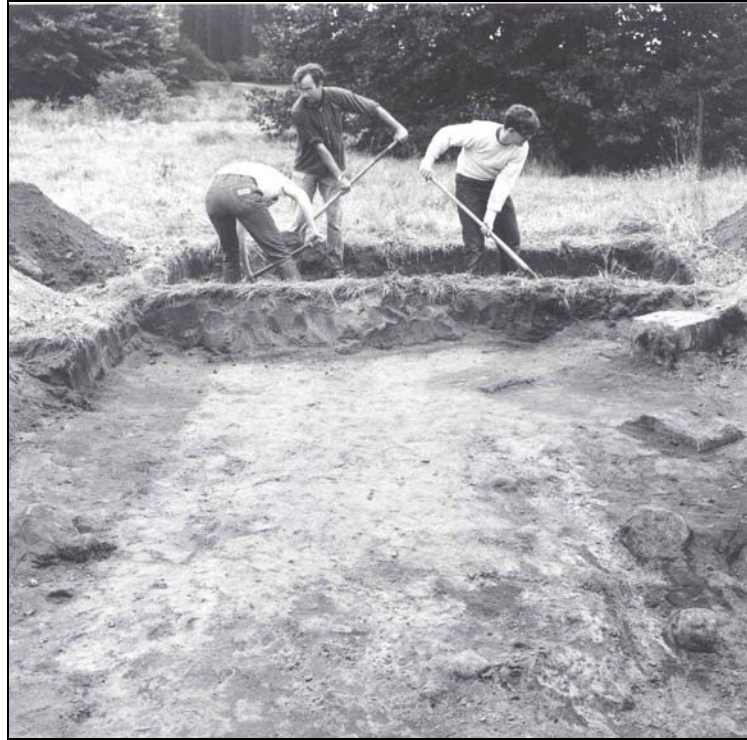
**Figure 119. Excavation of a section of the east branch of the Groton Road, 1964. (Photograph included in Leland J. Abel's "Archeological Explorations for Traces of the Historic Roads west of the Great North Bridge in Concord.")**

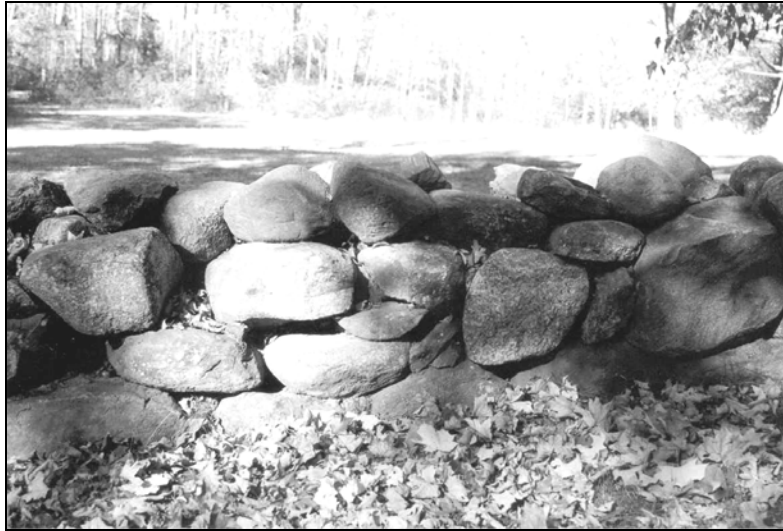
Figure 120. Stone wall (W-19), an example of a thrown stone wall found within the North Bridge Unit, 2003. (OCLP)

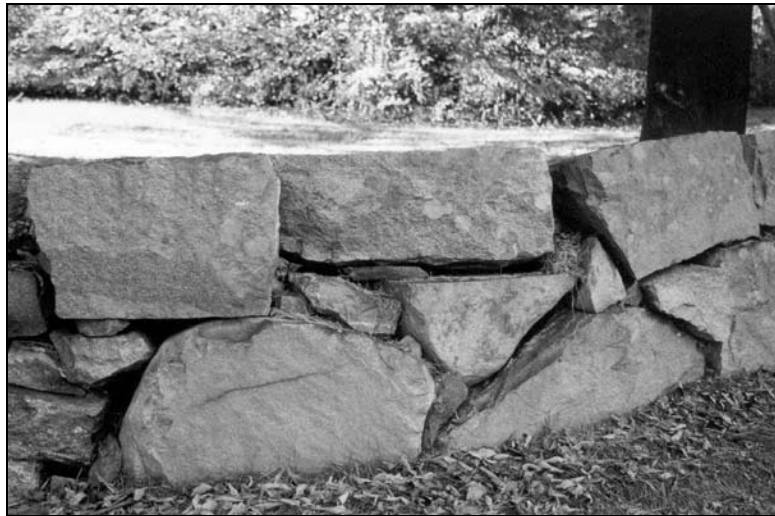
Figure 121. Stone wall (W-20), an example of a laid stone wall found within the North Bridge Unit, 2002. (OCLP)

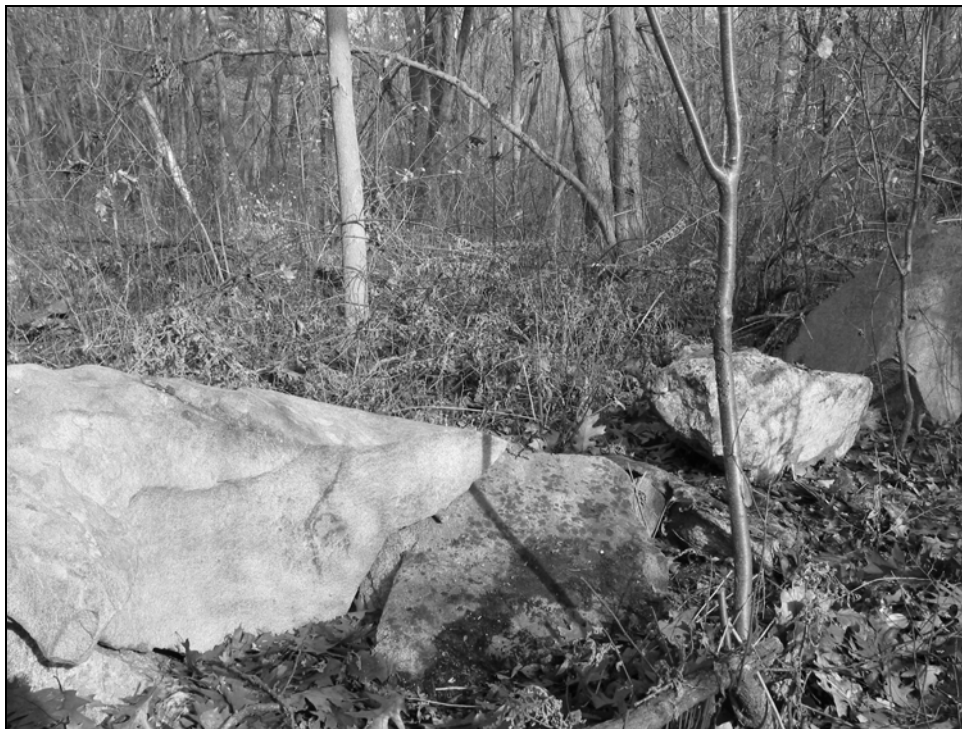
Figure 122. View north of the western section of stone wall (W-01), 2002. (OCLP)

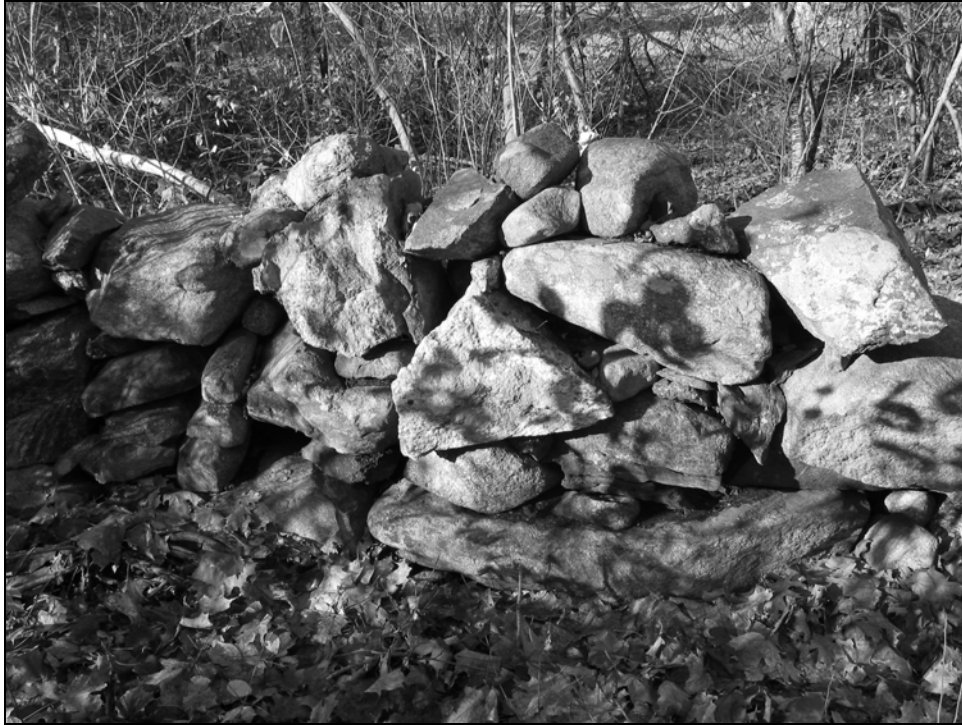
**Figure 123. View north (from South field near Monument Street) of stone wall (W-03), 2002. (OCLP)**

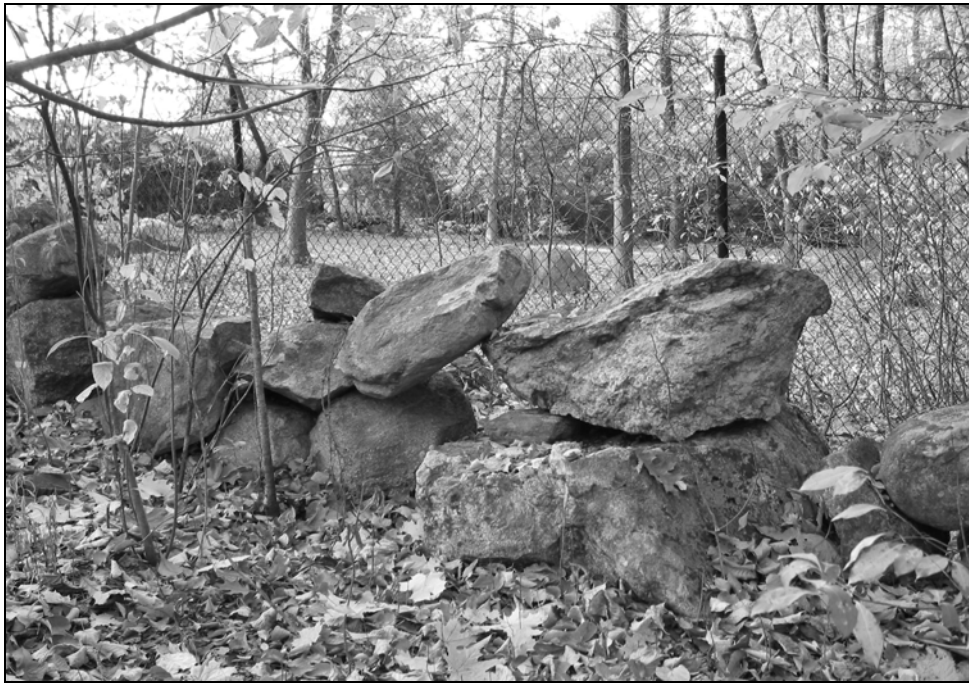
Figure 124. View southwest of stone wall (W-14), 2002. Chain link fence in back of the stone wall separates NPS property and private property. (OCLP)

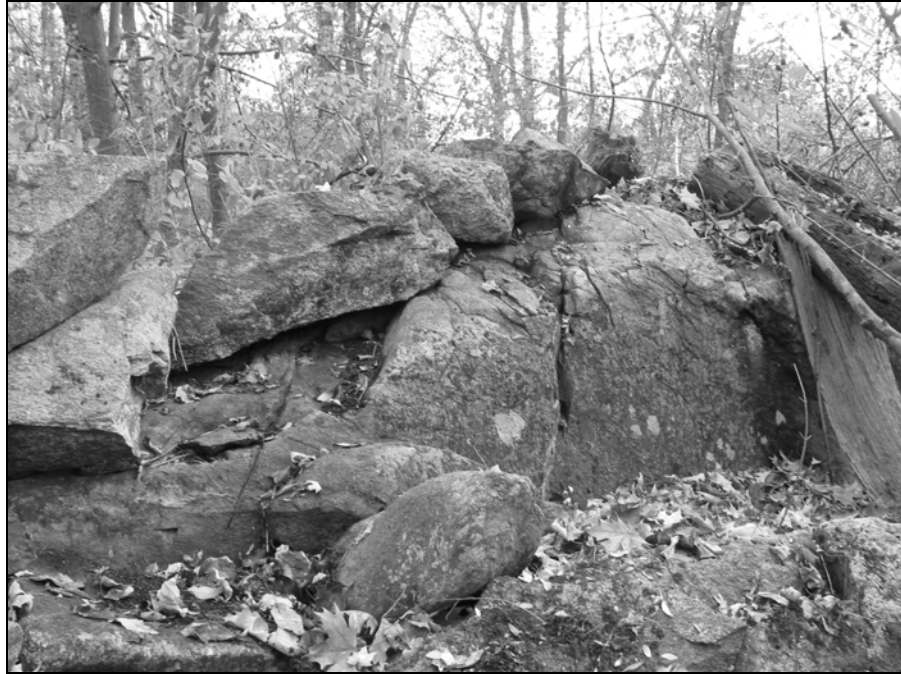
Figure 125. View west from Honeysuckle Island of stone wall (W-21), 2002. Photo depicts a section of wall (W-21) where wall construction incorporated a large unmovable boulder. (OCLP)

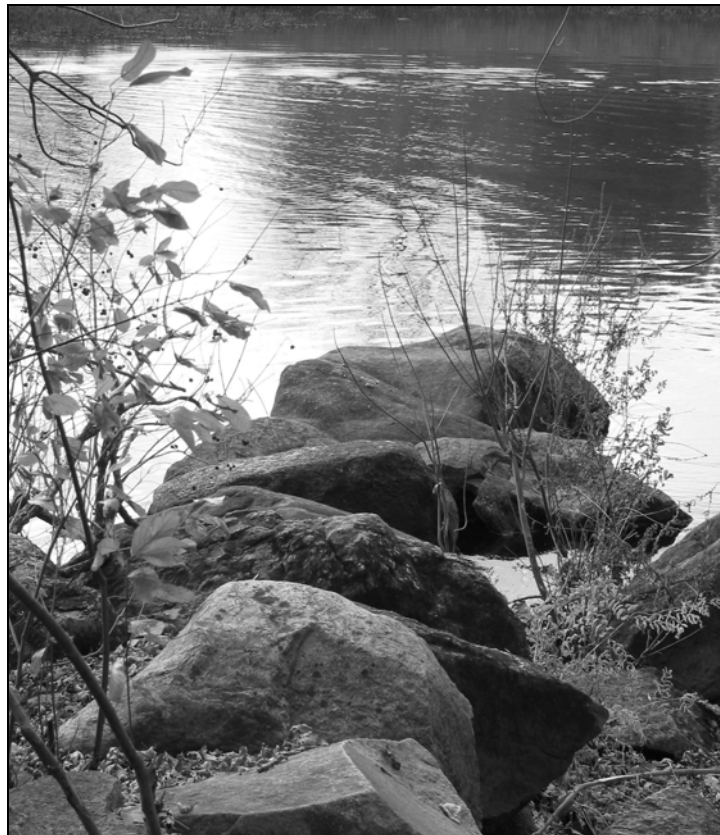
Figure 126. View southwest of stone wall (W-21), where the wall enters Concord River, 2002. (OCLP)

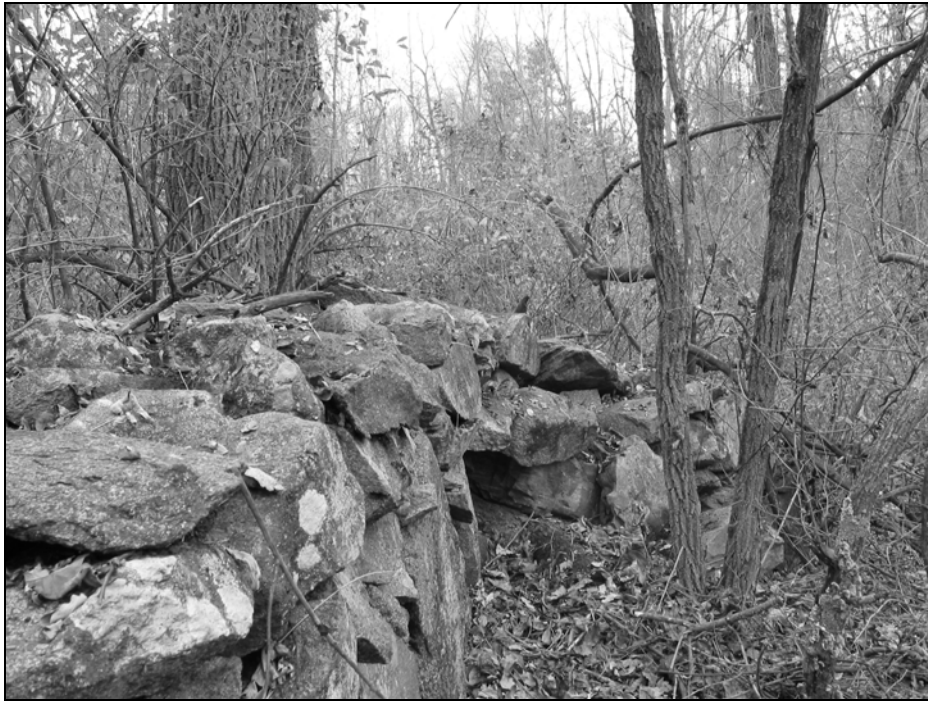
Existing Condition: The wall extends from Monument Street to the Concord River, along the 1909 property boundary between the Simmons houselot and property owned by the Concord Canoe Club. Only a section of what may have originally been a much longer stone wall exists. The section contains a mix of stone sizes, and measures 36 to 48 inches high by 30 inches wide. Both sides of the rubble wall are faced, and the top may have originally been capped. The section of the stone wall that remains is in fair to poor condition. In some areas stones have loosened and/or tumbled out of the wall. There are boulders west of the intact section of stone wall (W-22) that may mark the original line of the wall; however, heavy brush prohibits further investigation. A wooden post with remnant traces of wire fencing is located east of the intact section. The old wire fence appears to be an extension of stone wall (W-22) and is probably the section of the wire fence depicted on the 1962 plan mentioned above (Figure 127).

**Figure 127. View east from former Concord Canoe Club property (Simmons houselot) of stone wall (W-22) at the bend in the wall, 2002. (OCLP)**
